May 22, 2013

## Iran Laying Asphalt at the Suspect Parchin Site

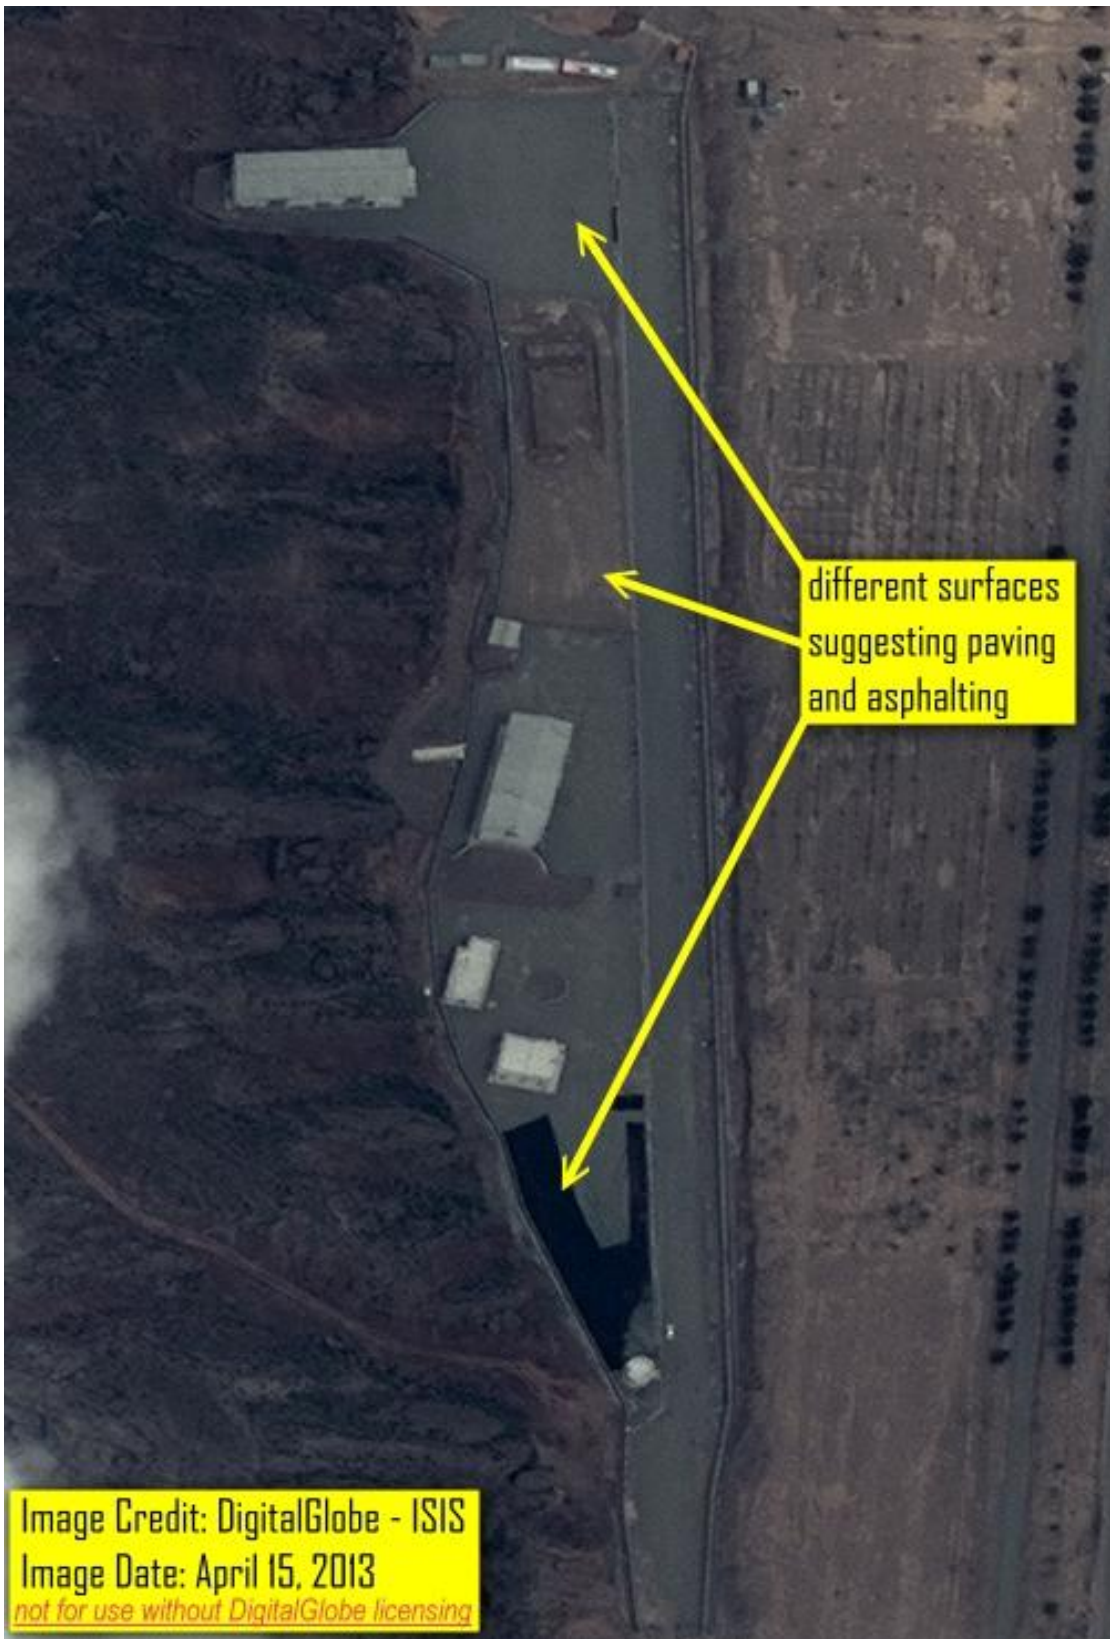
Figure 1. Digital Globe imagery from April 15, 2013 showing what appear to be the initial phases of paving and asphaltting activities on the grounds of the Parchin site. Differences can be noted in the indicated surface appearances from Figure 2's January 2013 image, suggesting different stages of construction.

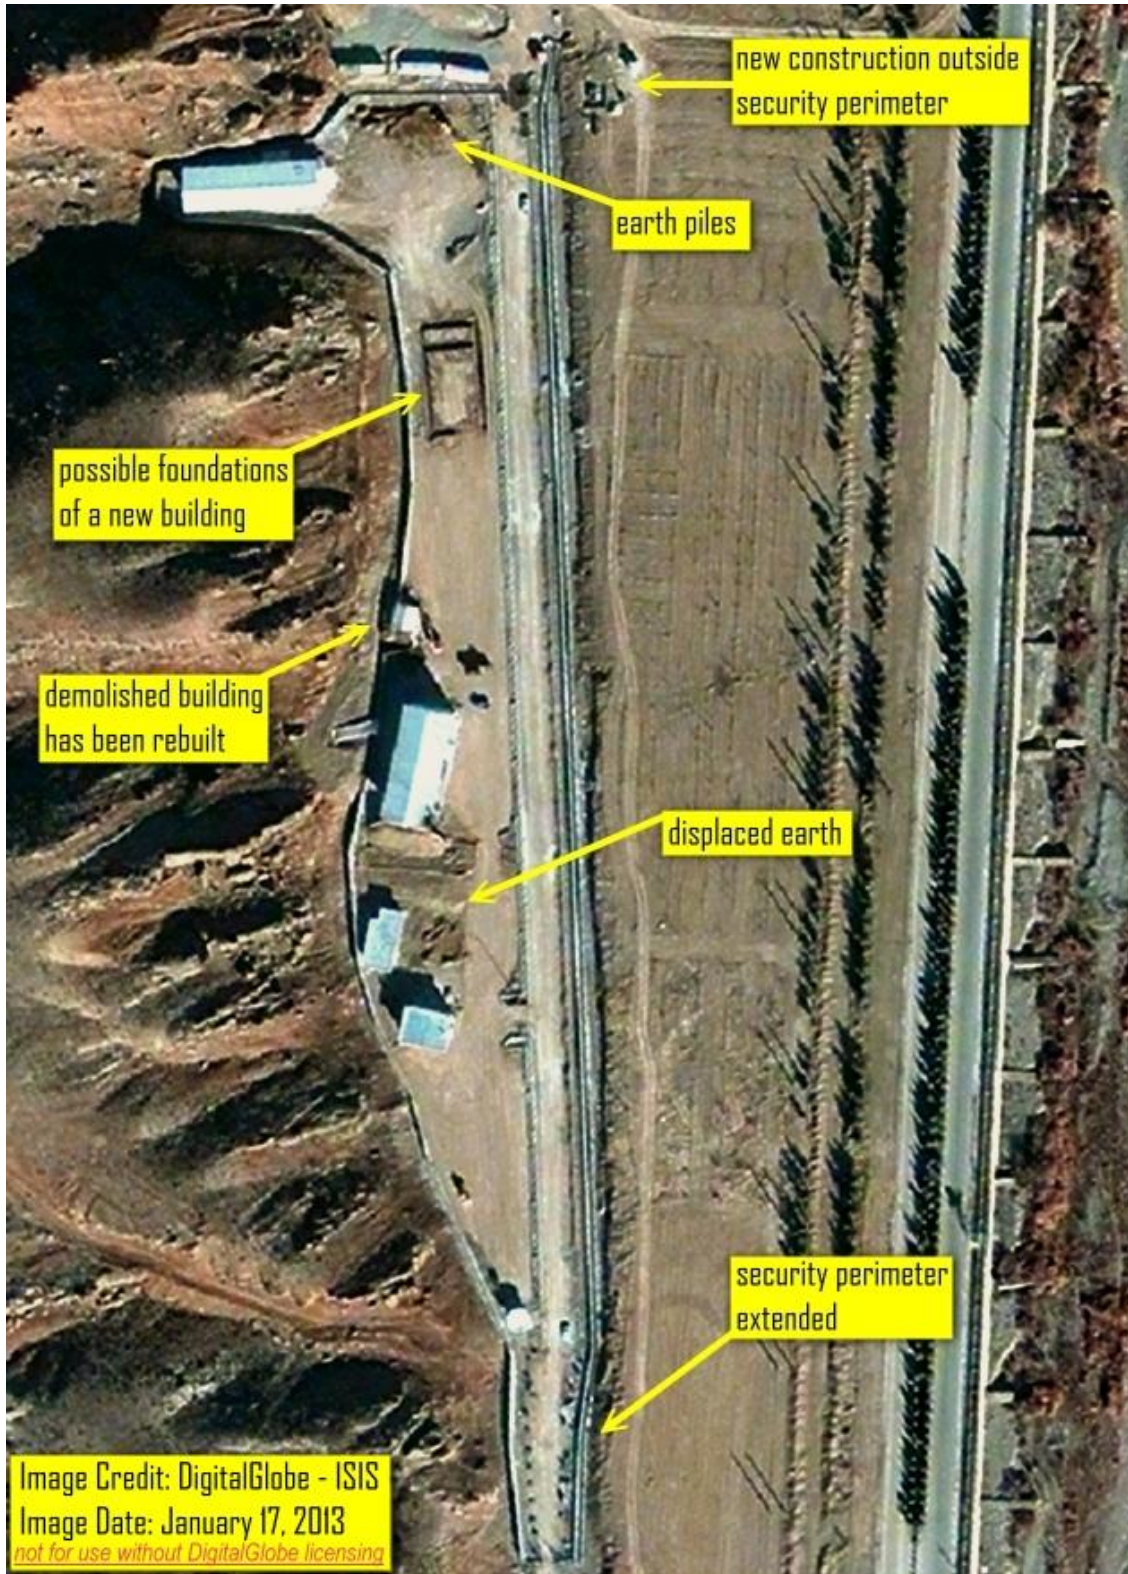
Figure 2. Imagery from January 17, 2013 showing no signs of paving or asphaltting. The grounds of the site appear to consist of compacted gravel compared to asphaltting seen in figure 1.
