No Significant Changes Visible at Parchin Nuclear Site

By David Albright and Serena Kelleher-Vergantini

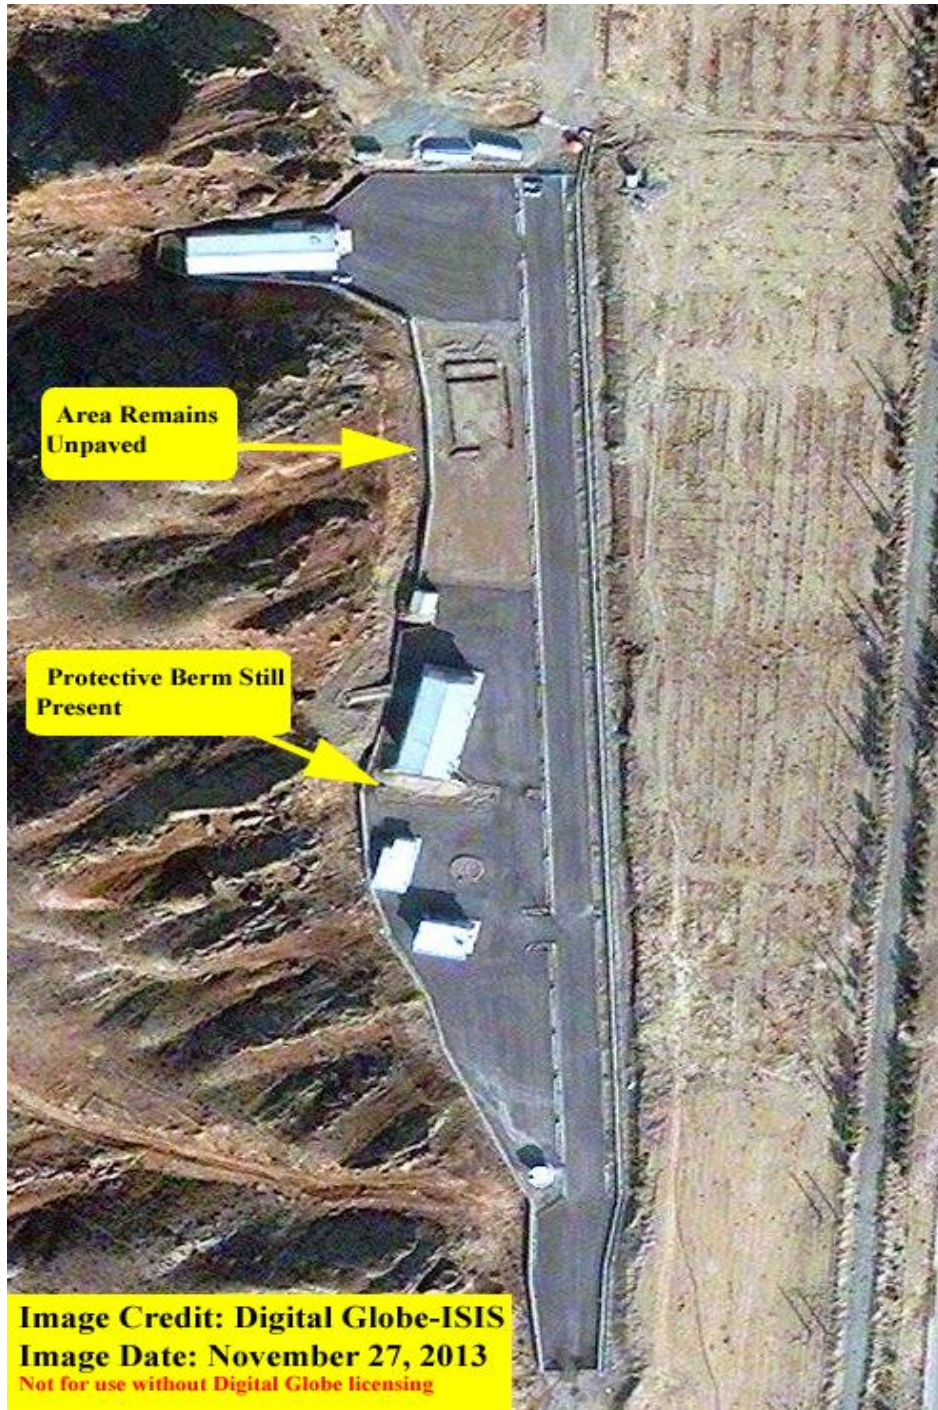
Recent commercial satellite imagery shows that during the last several months no significant alterations have taken place at the Parchin military site. At least one building at this site is alleged to have been the location of high explosive tests related to the development of nuclear weapons prior to 2004. A November 27, 2013 image shows that the areas that had previously been asphalted remain unchanged compared to an image from August 13, 2013 (see figures 1 and 2). A central area remains unpaved. In sum, no significant changes could be found at the site in the November image. We cannot see what is happening inside the buildings but the image does not show any activity associated with large-scale alterations inside the buildings.

Figure 1. Digital Globe imagery shows the status of the alleged high explosive test site at the Parchin military complex on November 27, 2013.

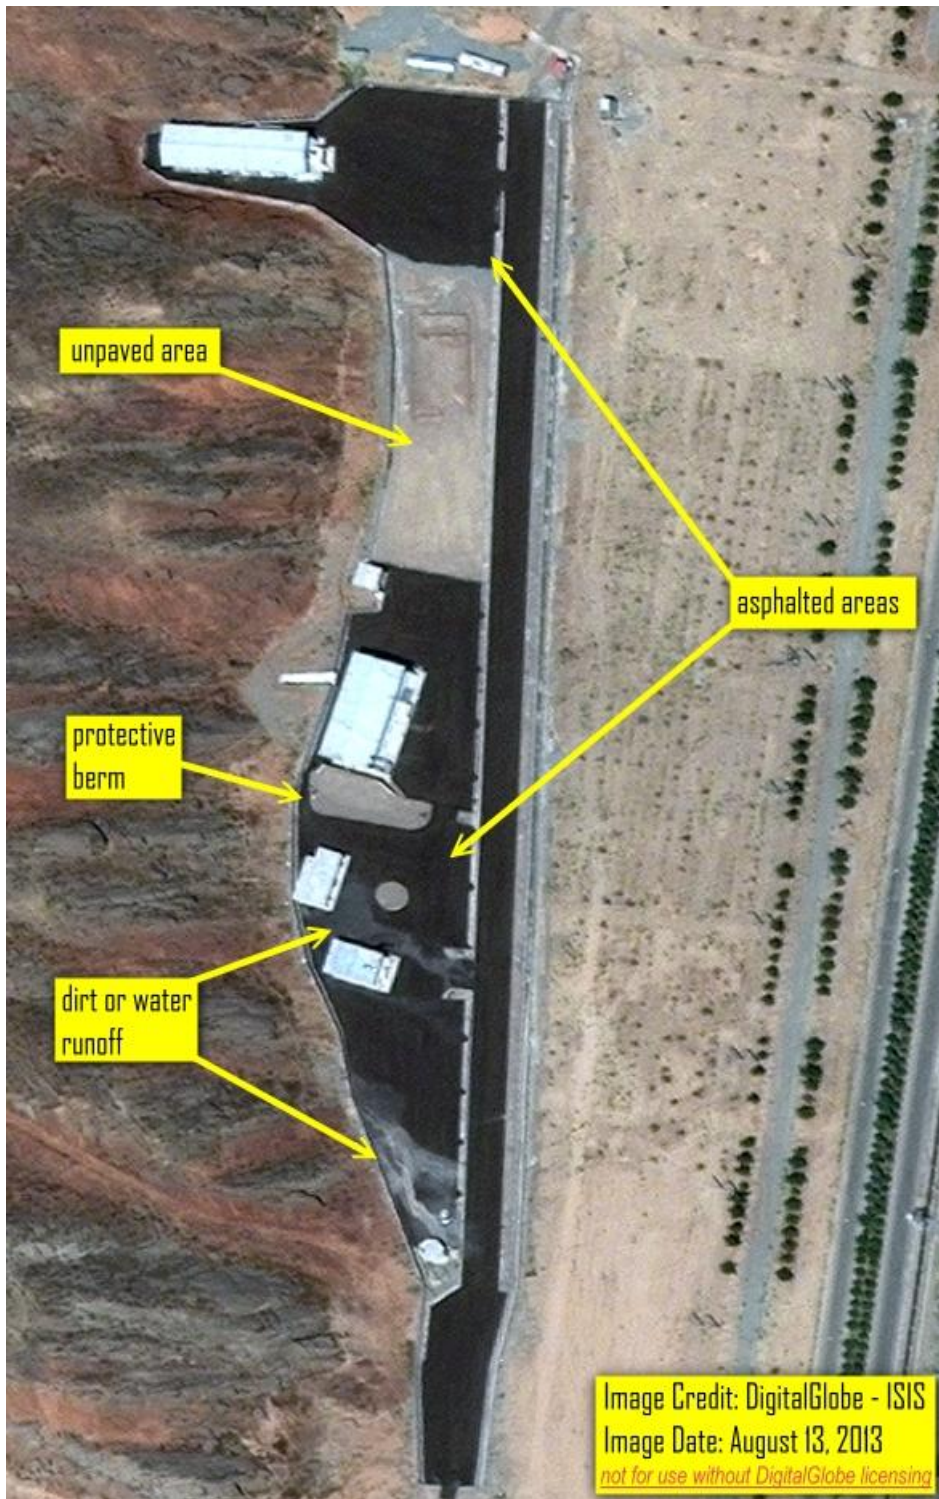
Since February 2012, ISIS has monitored developments at the Parchin complex using commercial satellite imagery to catalog changes at the site. These results are in reports available on the [ISIS website](#). The imagery shows that between early 2012 and the summer of 2013 Iran sanitized, demolished portions of, and reconstructed the site in an apparent effort to hide past activities and undermine the International Atomic Energy Agency's (IAEA's) ability to conduct verification activities (compare figures 2 and 3).

Figure 2. Digital Globe imagery shows the status of the alleged high explosive test site at Parchin in August 2013.

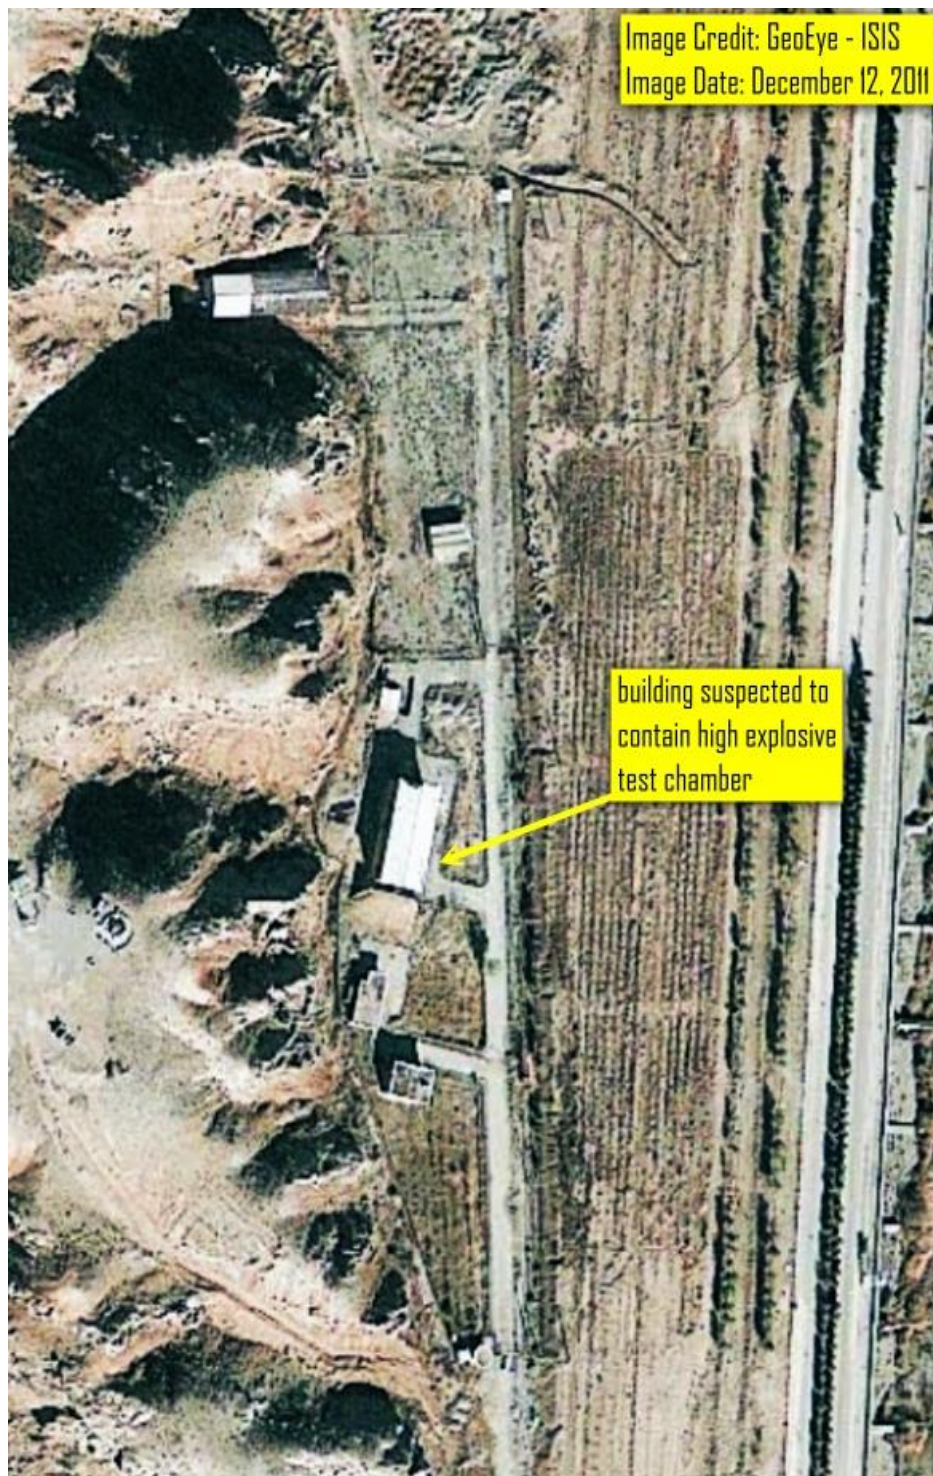
Figure 3. GeoEye imagery dated December 12, 2011 showing original buildings, security perimeter, and layout of Iran's Parchin site prior to the February 2012 IAEA request to access the site. After this request, Iran undertook a series of construction efforts to alter the site. These resulted in the complete alteration of the internal layout, modification and demolition of several buildings, and construction of a new security perimeter.
