May 30, 2012

## Further Activity at Suspected Parchin High Explosive Testing Site: Two Small Buildings Razed

By David Albright and Robert Avagyan

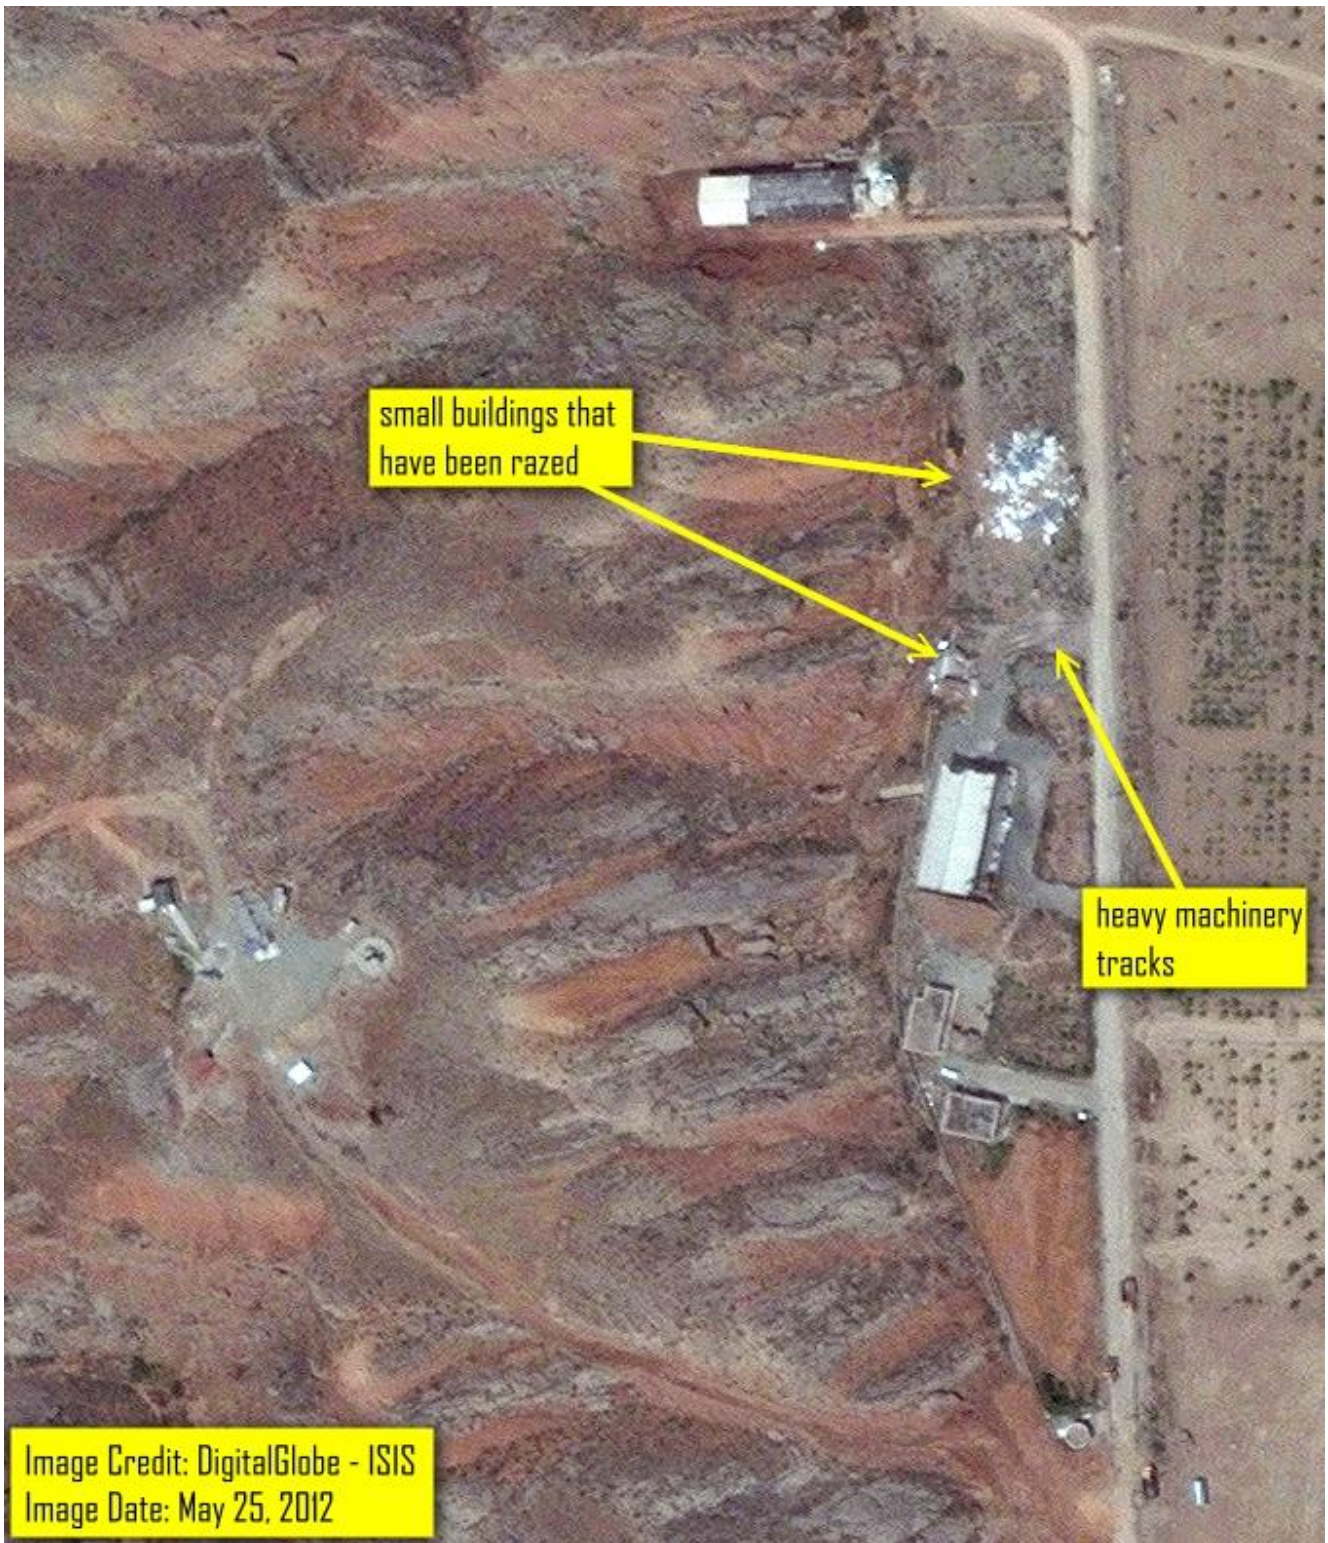
Figure 1. Imagery from May 25, 2012 showing the razing of two small support buildings. It also shows heavy machinery tracks near the site

DigitalGlobe satellite imagery from May 25, 2012 shows that two small buildings at the same site as the suspected testing chamber have been completely razed (figure 1). There are visible tracks made by heavy machinery used in the demolition process. Heavy machinery tracks and extensive evidence of earth displacement is also visible throughout the interior as well as the exterior of the site's perimeter (figures 2 and 5).

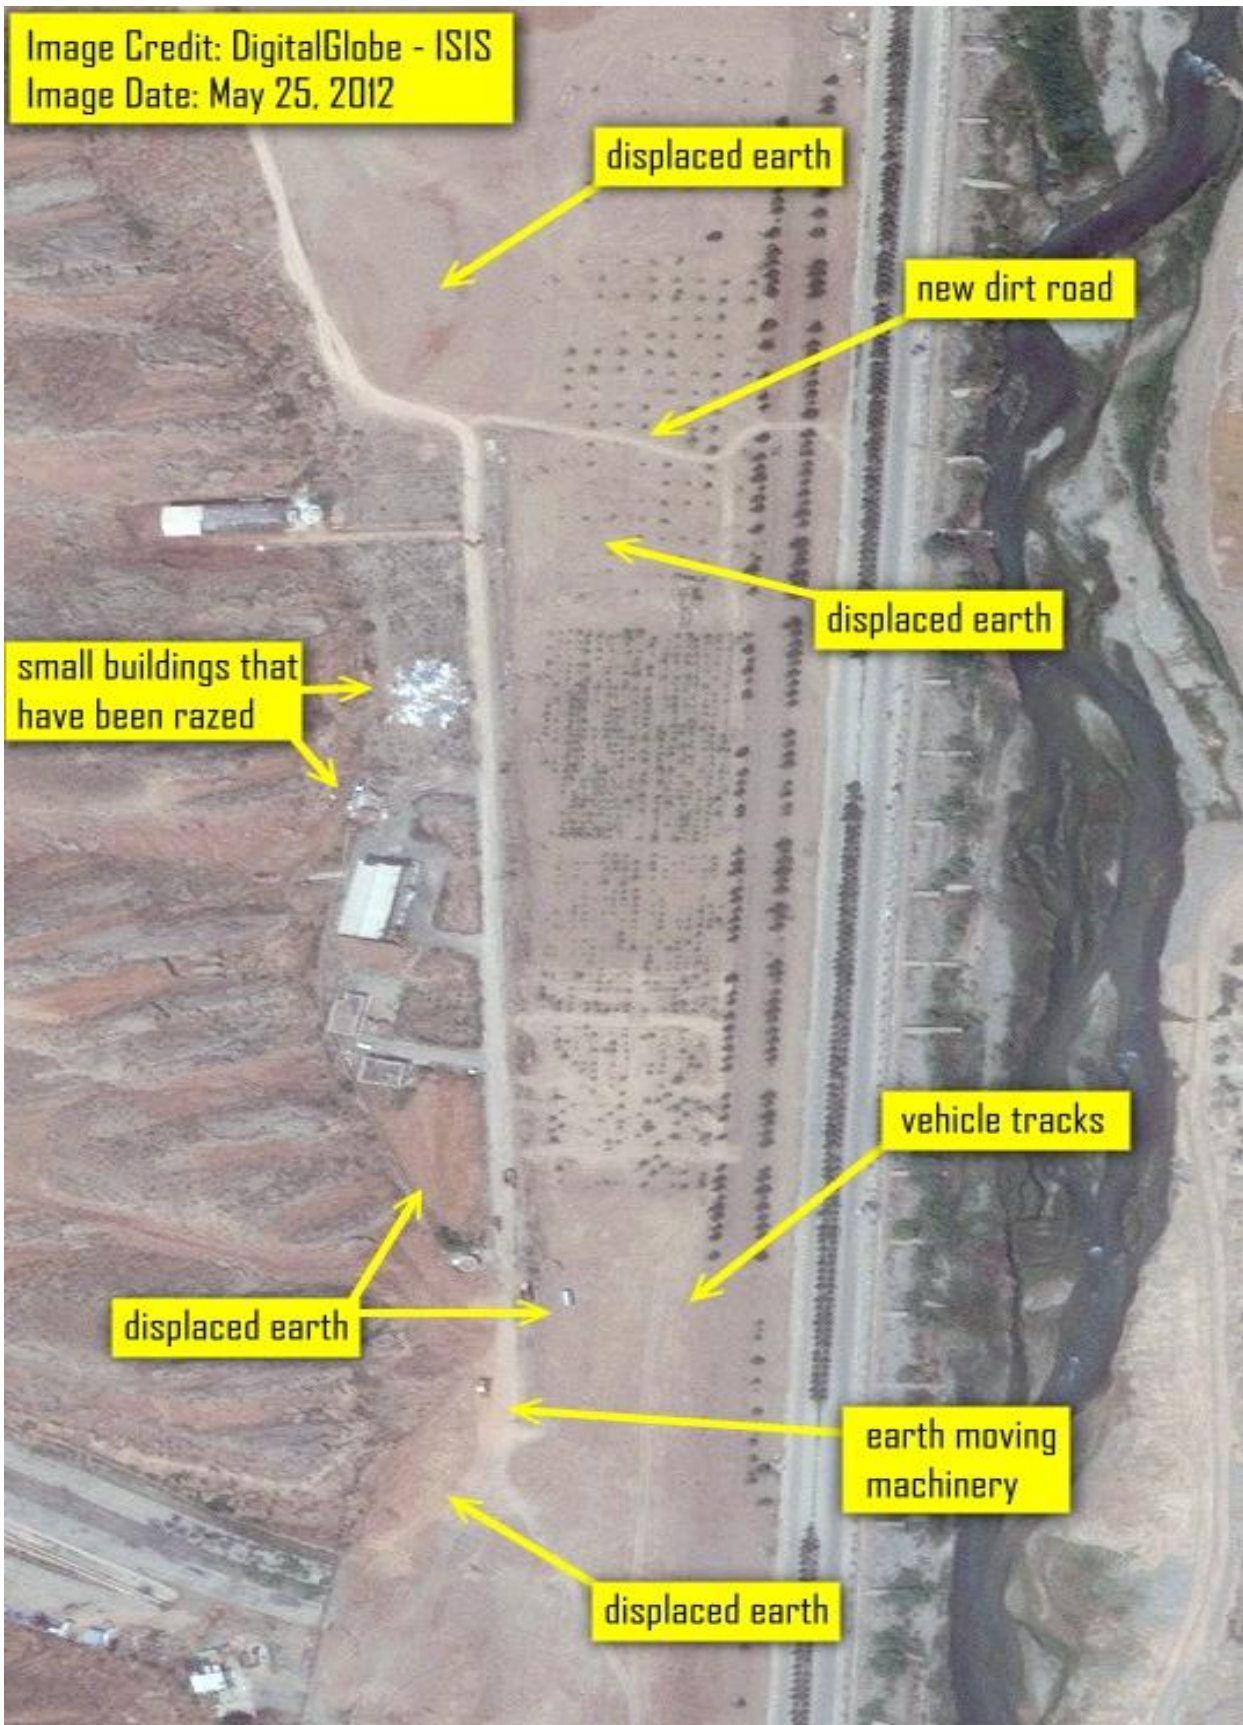
Figure 2. Wide view image of the suspected high explosive testing site showing extensive evidence of earth displacement activity.

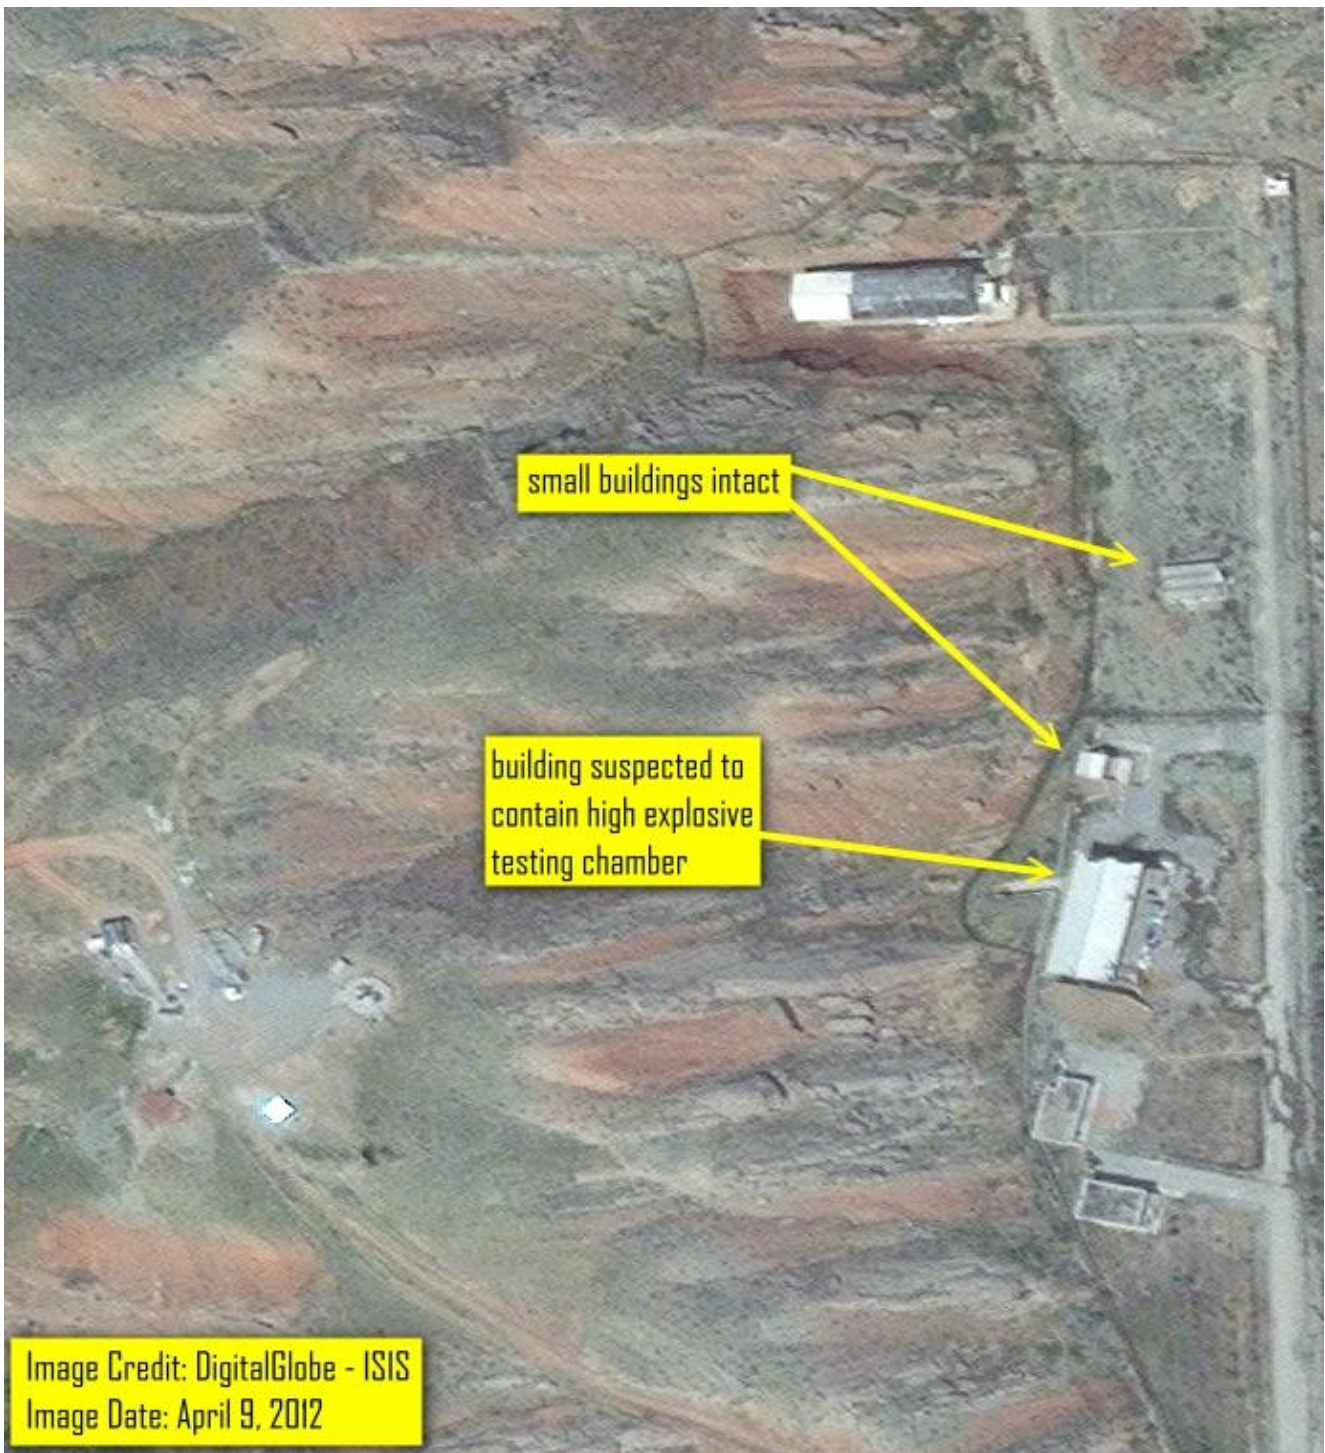
Figure 3. Imagery from April 9, 2012 showing the two small buildings intact near what is suspected to be the high explosives testing building.

This new round of activity has followed suspected cleanup activities in the explosives testing chamber building, which are visible in an April 9, 2012 satellite image published in an earlier ISIS [report](#) (figure 4). In the April 9, 2012 image, the two support buildings are intact (figure 3).

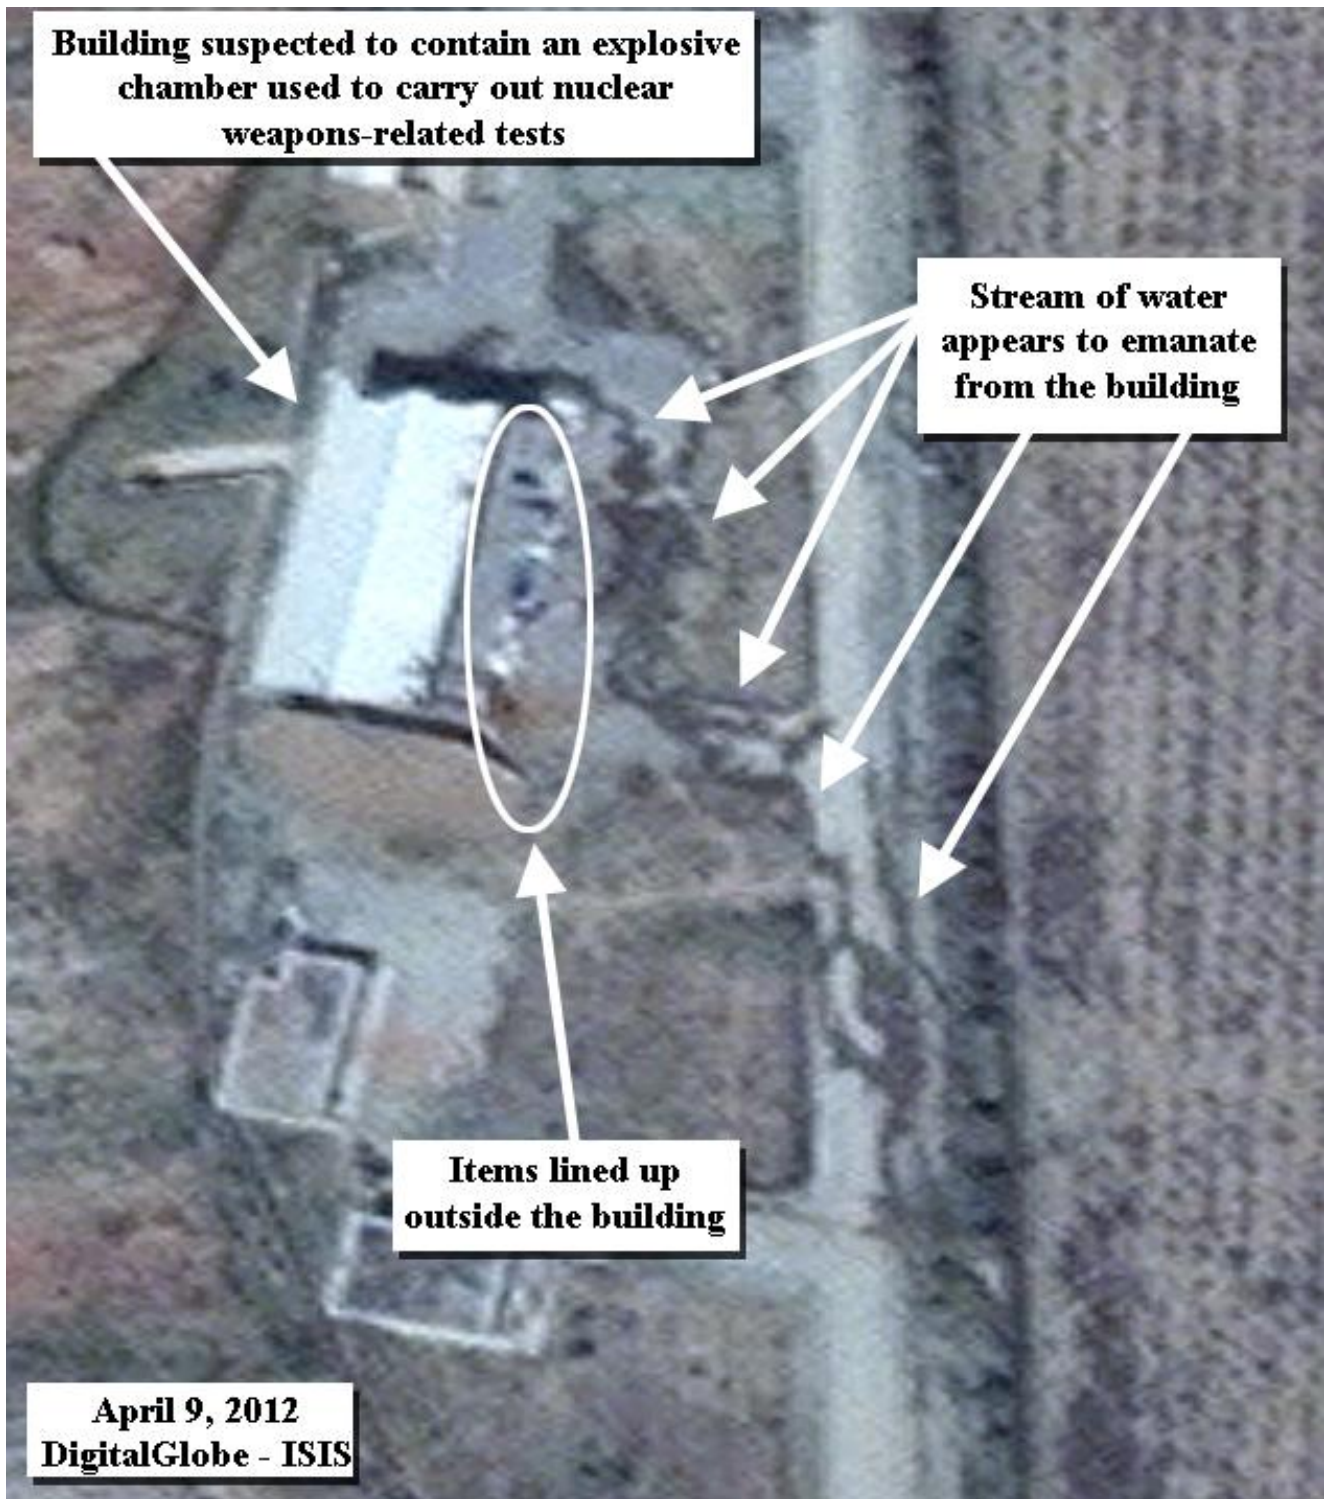
Figure 4. Imagery from April 9, 2012 showing suspected cleanup activities at the building alleged to contain the high explosive chamber used for nuclear weapon related tests.

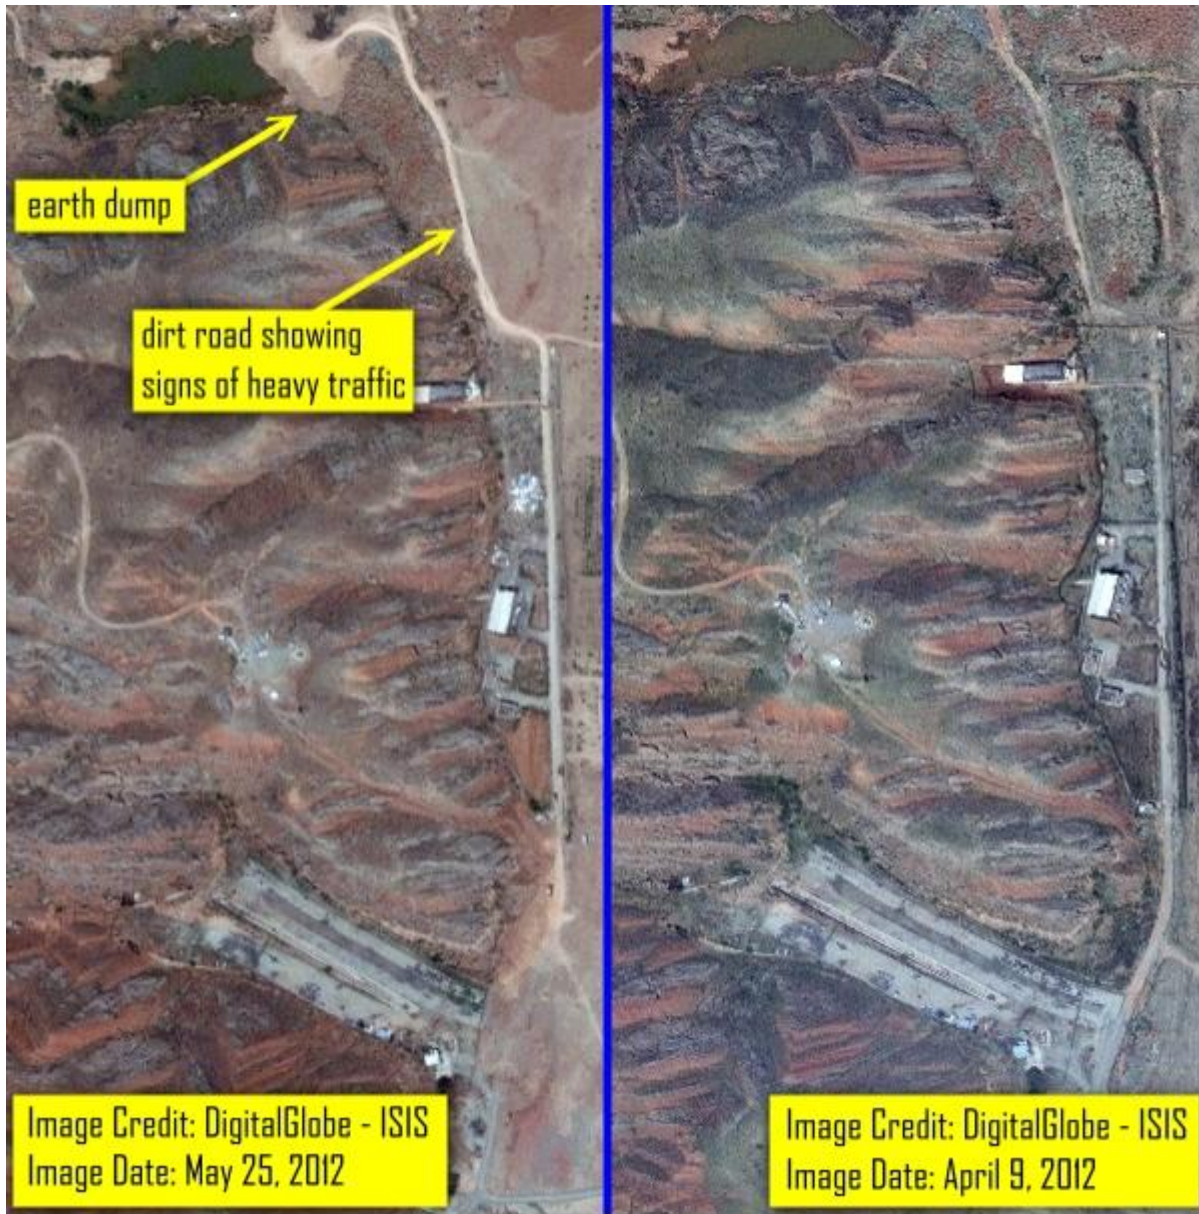
Figure 5. Evidence of extensive earth dumping in the pond to the north of the Parchin high explosive test site. Signs of fresh traffic on road leading to pond.
