August 24, 2012

New Phase of Suspect Activity at Parchin Site

By David Albright and Robert Avagyan

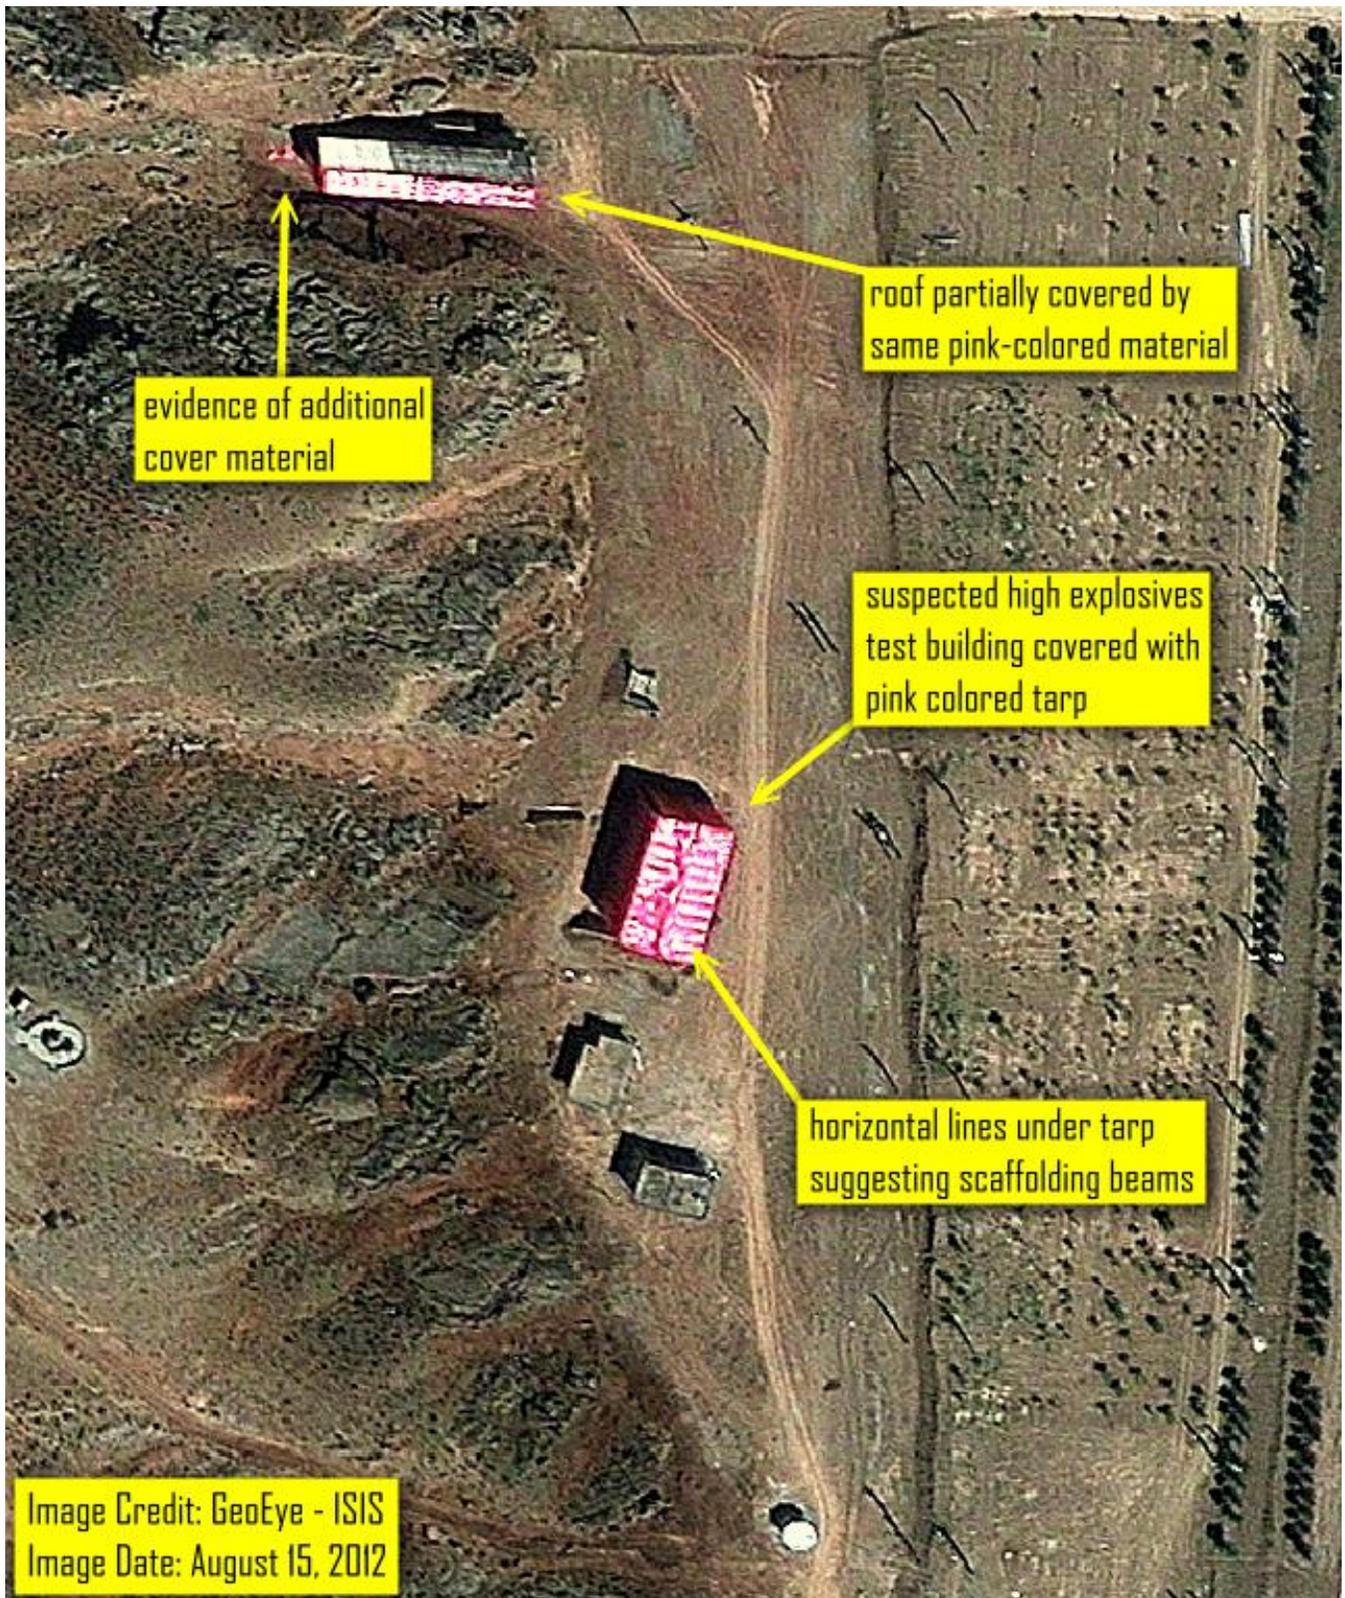
Figure 1. GeoEye satellite image from August 15, 2012 showing the suspected high explosives test building covered with a tent like material most likely supported by scaffolding. An adjacent building to the north also appears partially covered with the same material.

The latest satellite imagery clearly shows the suspected high explosive test building covered in a pink-colored material. A comparison with previous satellite images of the building shows that the size of the now covered building has visibly increased, especially in its height. In consultation with experts ISIS believes that the covering tarp is supported underneath by scaffolding which would account for the increase in size as well as for the horizontal lines appearing under the tarp (figure 1).

Similar activities appear to be taking place at the northernmost building at the site. Currently only part of the roof appears covered by the pink-colored tarp; however, similarly colored material is visible on the ground next to the building suggesting that it may soon be covered.

The purpose of covering the buildings could be to conceal further cleanup activity from overhead satellites or to contain the activity inside. Depending on how effective of a seal the tarp provides, the goal could be continue sanitizing the inside and outside of the building that is suspected to contain particles indicative of nuclear weapons development work. Alternatively tarps could provide a cover for the demolition of the buildings, or portions of them, while also containing the spread of potentially contaminated debris.

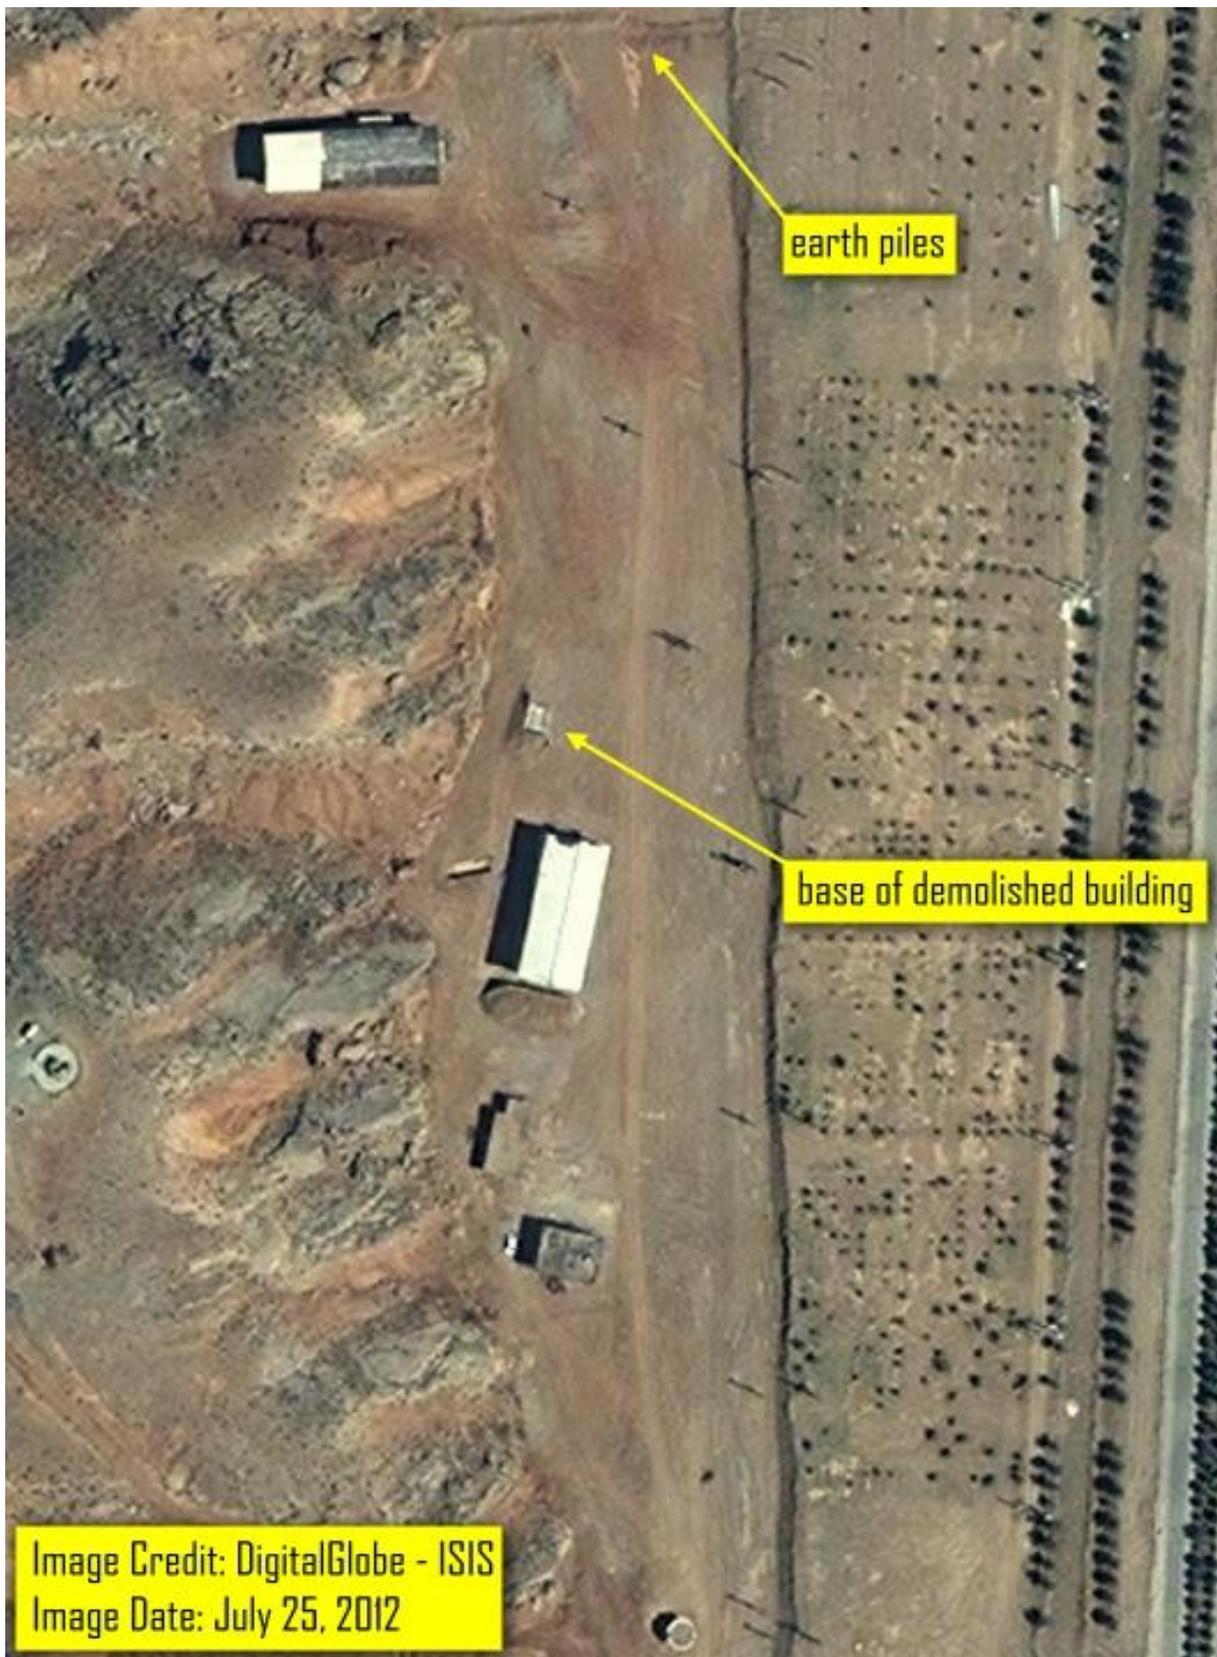
Figure 2. Satellite image from July 25, 2012 showing the results of the extensive alterations undergone by the suspected high explosives testing site following the demolition of two buildings and major earth displacement activities.
