Major Cleanup Activity at Suspected Parchin High Explosive Test Site Appears Complete: Site Considerably Altered

By David Albright and Robert Avagyan

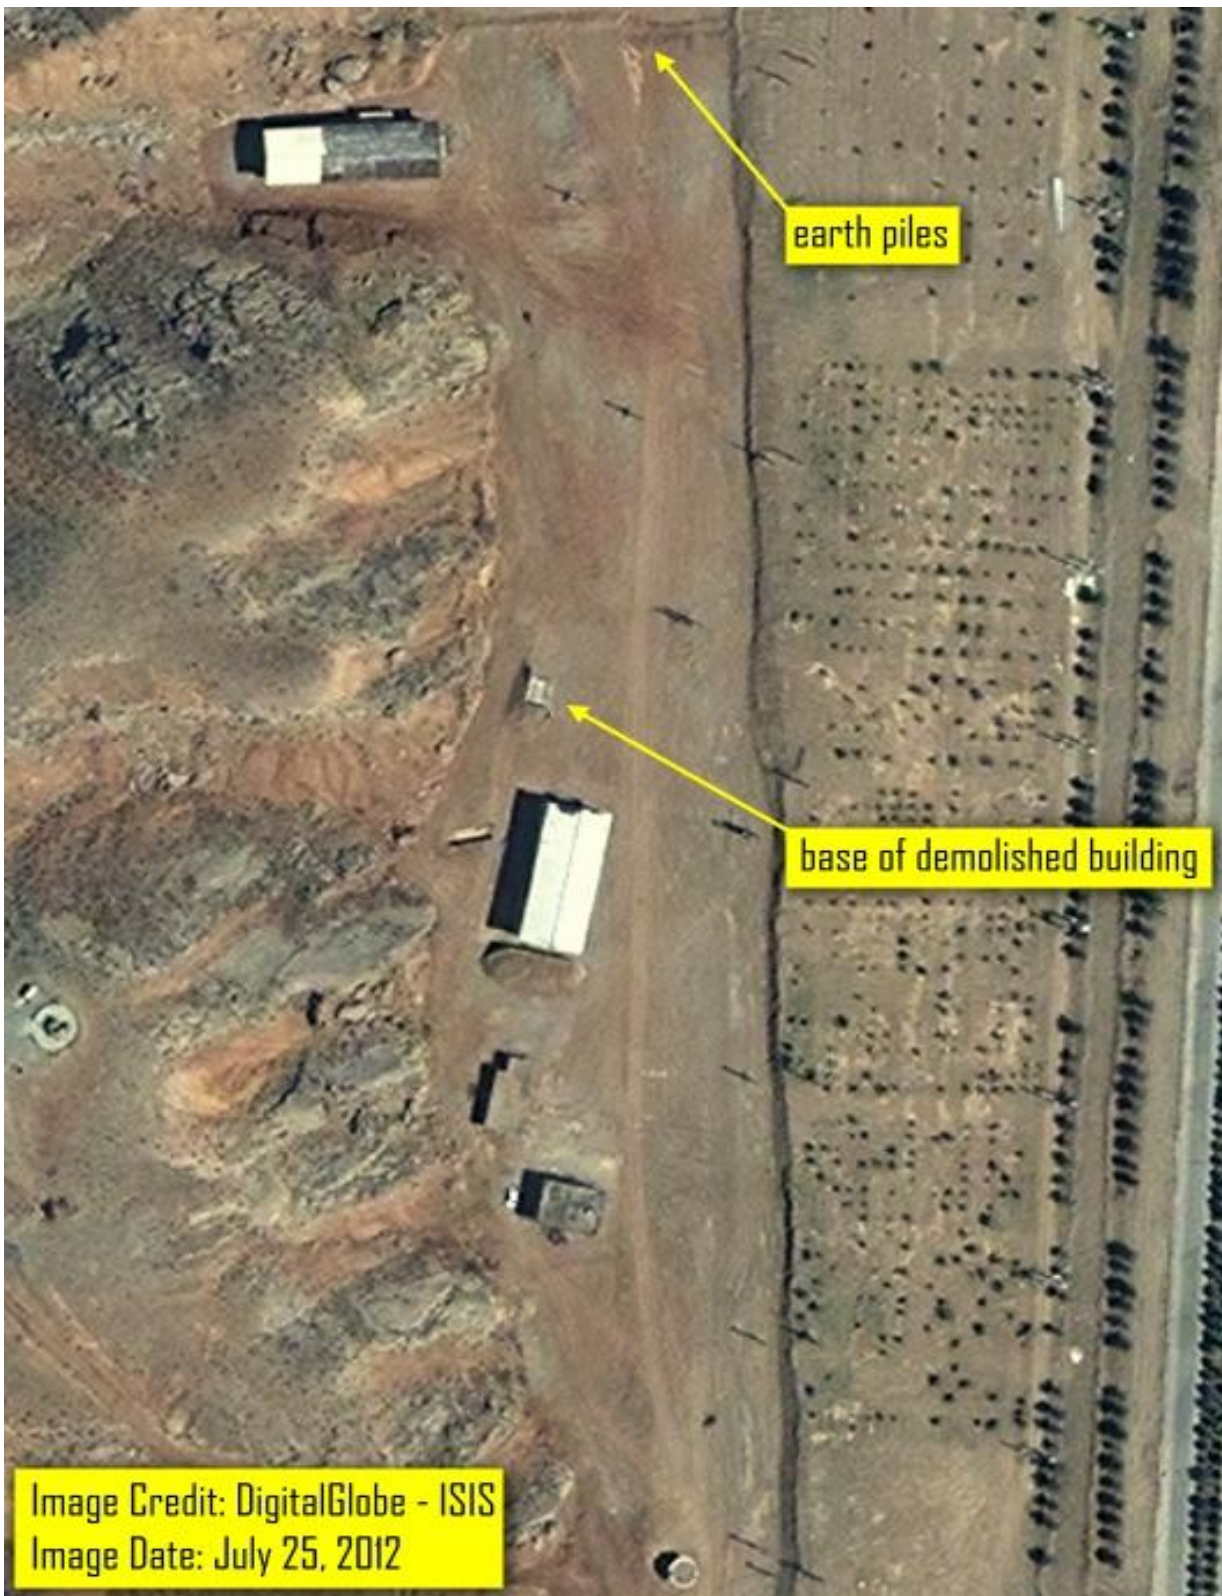
Commercial satellite imagery from July 25, 2012 of a site at the Parchin military complex shows what appears to be the final result of considerable sanitization and earth displacement activity (see figure 1). The International Atomic Energy Agency (IAEA) suspects that this complex contains a high explosive testing chamber that was used for nuclear weapons related development.

Figure 1: Satellite imagery showing the result of extensive alterations to the suspected Parchin high explosive test site.

The latest image from July 25, 2012 shows stark differences in the site's current layout from earlier imagery in figure 2. The entire area surrounding the buildings appears to have been bulldozed, covered, and flattened. The only remaining traces of activity are the apparent base of one of the demolished buildings and earth piles formed as a result of earth removal and displacement (figure 1). There are no traces of heavy machinery or construction materials suggesting that no major activity is planned in the near future.

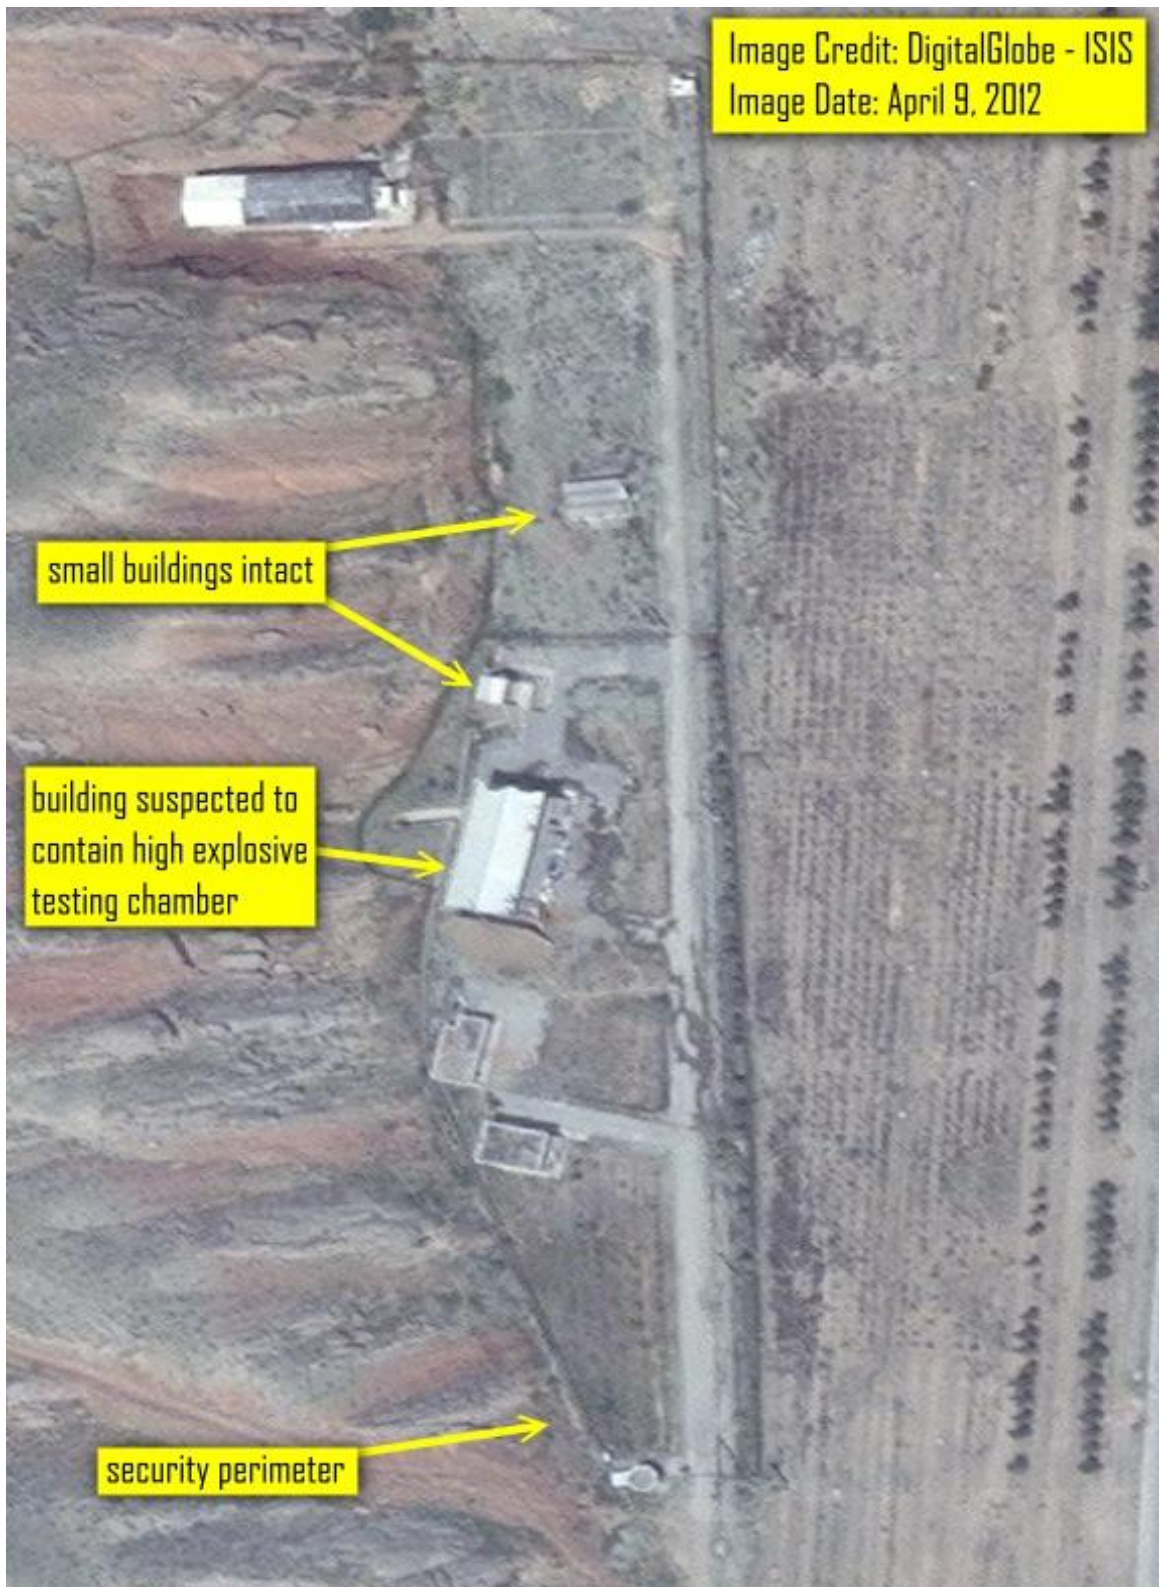
Figure 2: Imagery from April 9, 2012 showing the Parchin site before the start of major alterations to the site's layout. The objects lined up outside the high explosive test building and water flow suggested the start of suspected cleanup activities.
