## **Parchin High Explosives Test Site Activity Still Ongoing**

By David Albright and Robert Avagyan

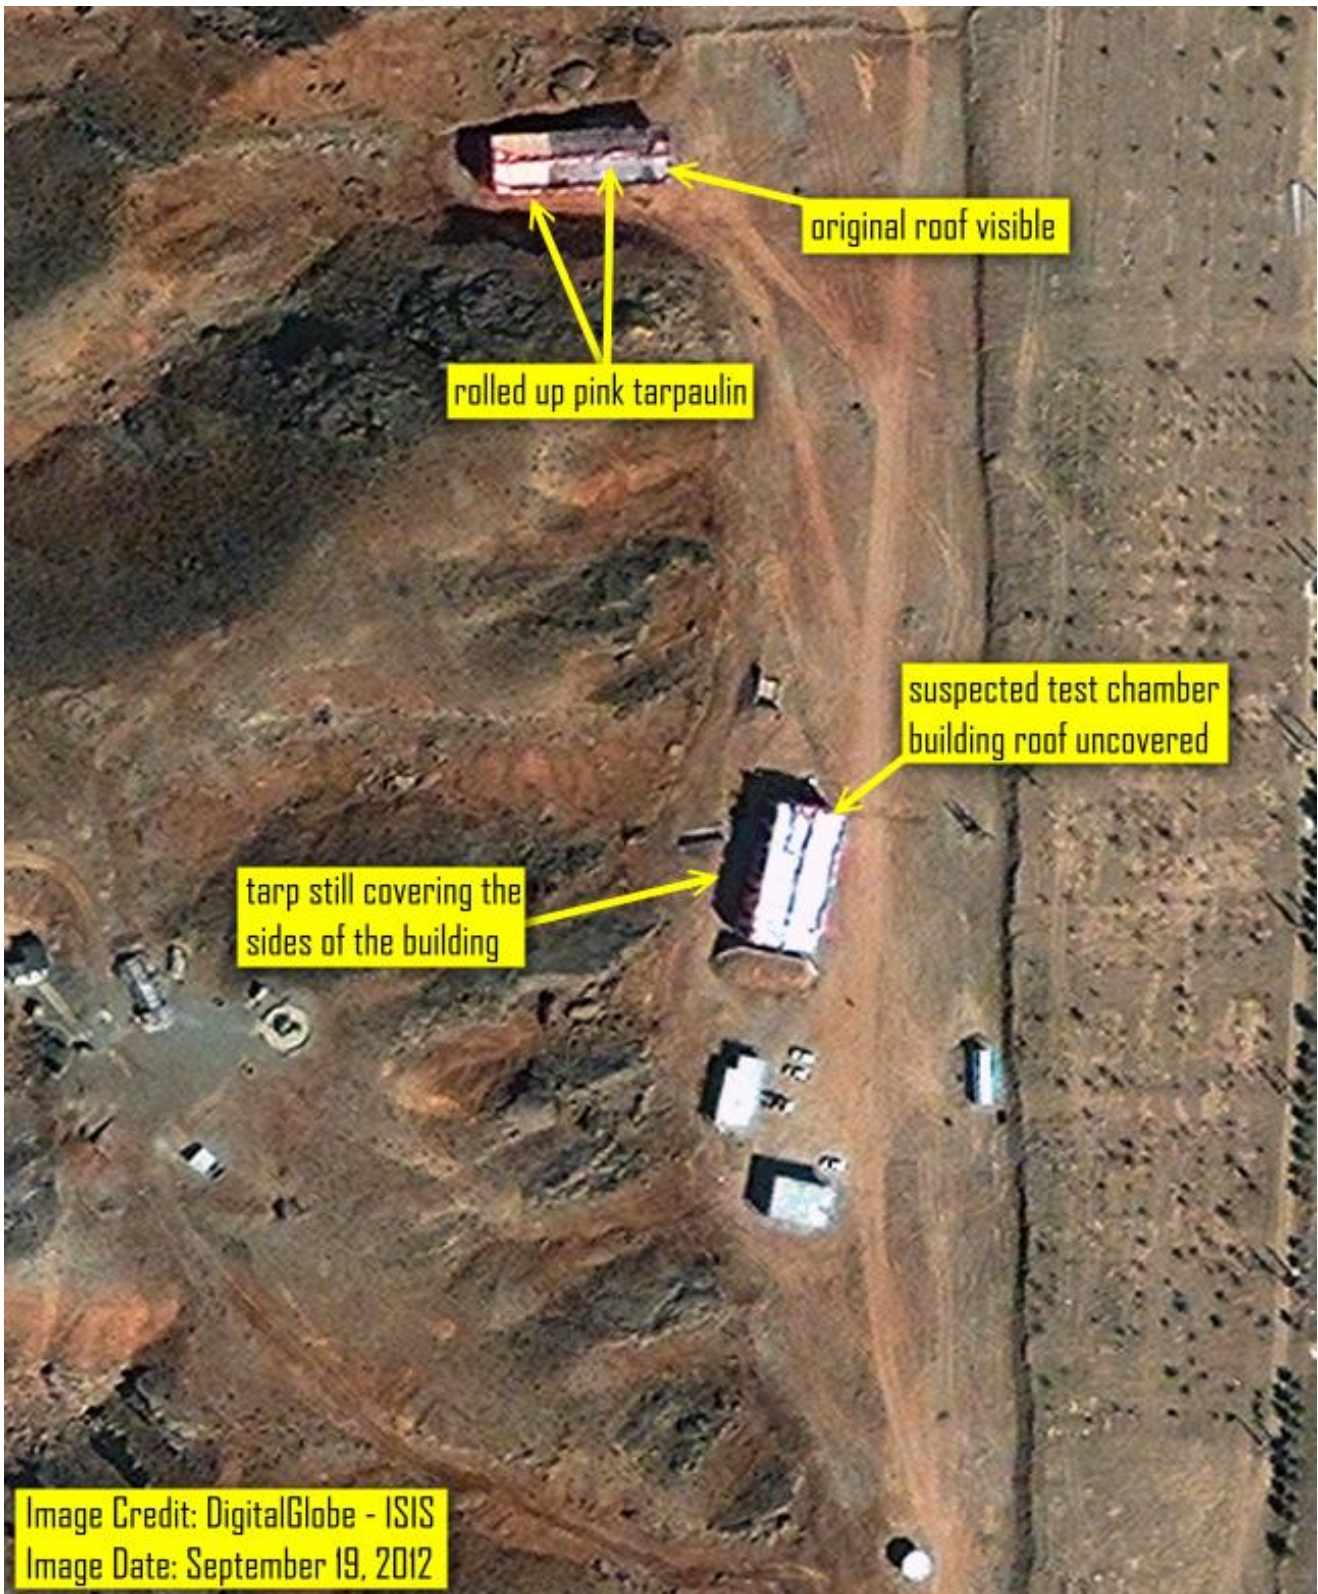
Figure 1: In the latest satellite imagery, the covers placed on the two major buildings at the Parchin site seem to be in the process of being removed. The original roofs of the two buildings are now visible, as are rolled up lines of pink tarpaulin.

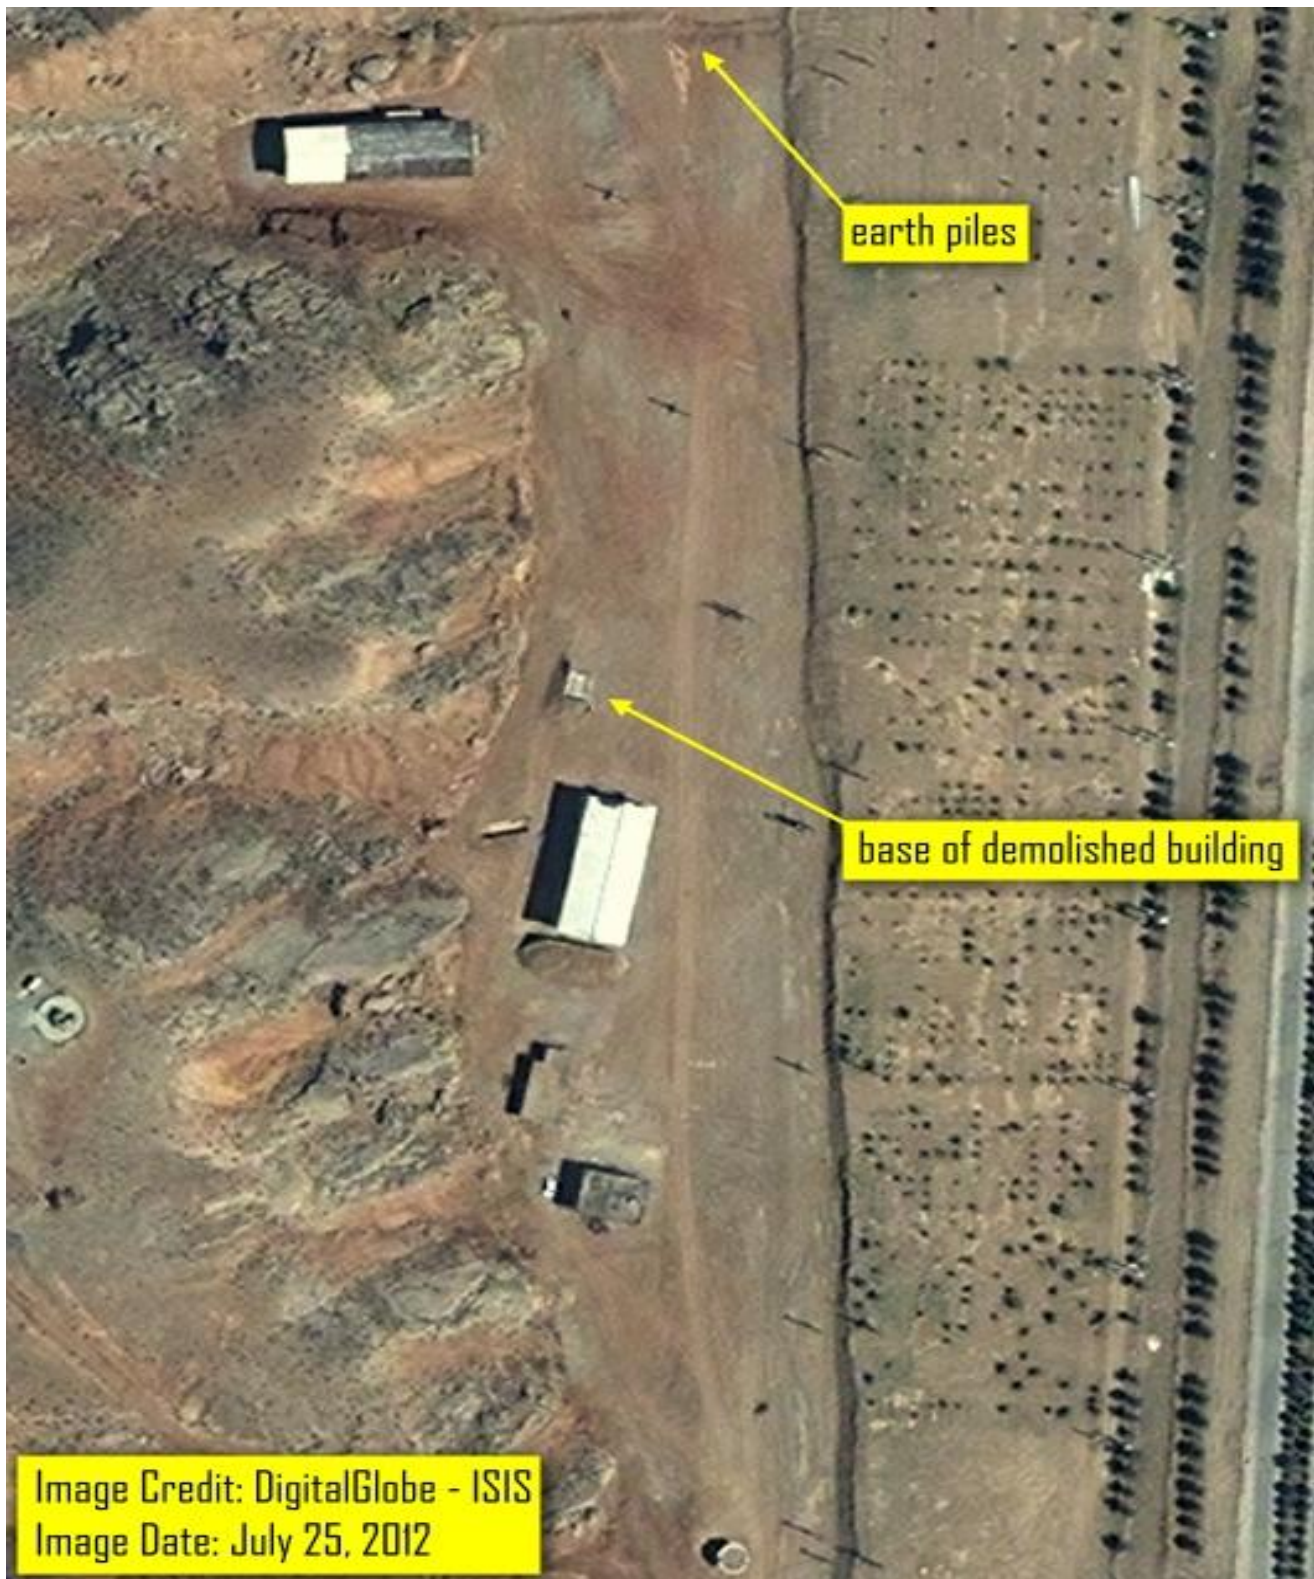
Figure 3: Imagery from July 25, 2012 showing what appears to be the final phase of major demolition and earth moving activities that heavily altered the site over the course of four months. The original state of the roofs of the two buildings later covered with tarpaulin is clearly visible in this image.
